Cerbo GX power supply issue in 48V systems

Technote August 2022 – v7 – 2021-09-29

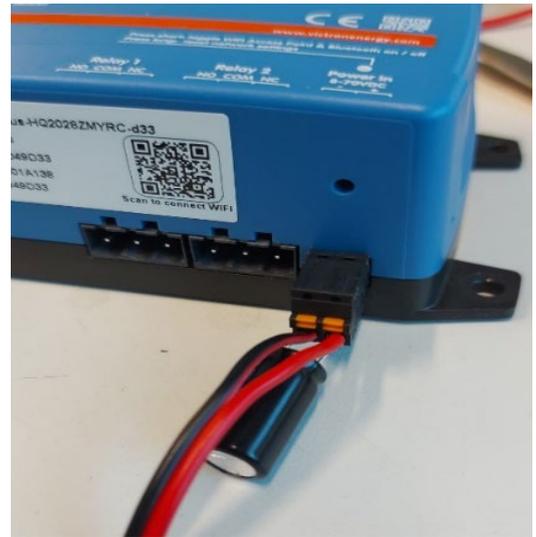
Add a capacitor on the input, in parallel to the power wiring, as shown in picture on the right.

We recommend to isolate the pins with a small piece of heat shrink, as shown in the second photo.

Carefully check proper connection of both the capacitor and the Cerbo power wires. The factory power cables are bootlace ferrule terminated and the smaller capacitor leads will be loose if not carefully aligned. We recommend to cut the factory bootlace ferrules off and re-terminate the wire and the leads of the capacitor into new bootlaces.

The capacitor needs to stay there permanently.

Make sure to connect the capacitor first; and only thereafter apply power (!).

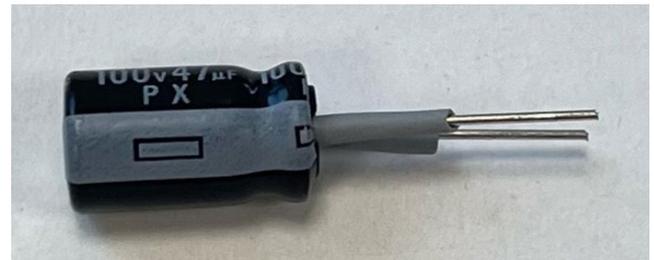
The capacitor has a minus (–) polarity marker. It is the white band with the minus in it, as shown on the picture here on the right. The pin on that side is the minus pin, and must be inserted into the minus terminal on the Cerbo GX.
